**National Highway  
Traffic Safety  
Administration**

186-00

Case Vehicle (A): 1998 Plymouth  
Type: Breeze Expresso, 4-door sedan  
Driver: 57-year-old female  
CDC: 12-FZAW-4

Veh. (B): 1994 Peterbilt  
Type: Model 377 6 x 4 tractor with trailer  
Driver: 60-year-old male  
CDC: 99-0000-0

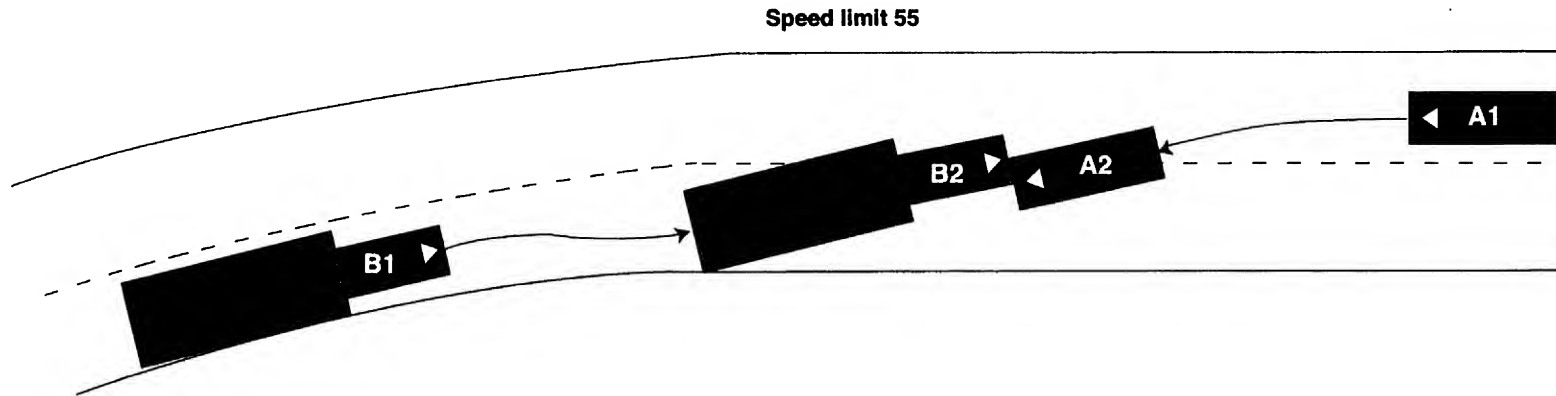
# ACCIDENT SCHEMATIC

ACCIDENT DESCRIPTION: Case vehicle (A) was traveling west and  
vehicle (B) was traveling east on the same road. Case  
vehicle (A) crossed the centerline, vehicle (B) tried to  
veer out of the way, but struck case vehicle (A) in the right-front.

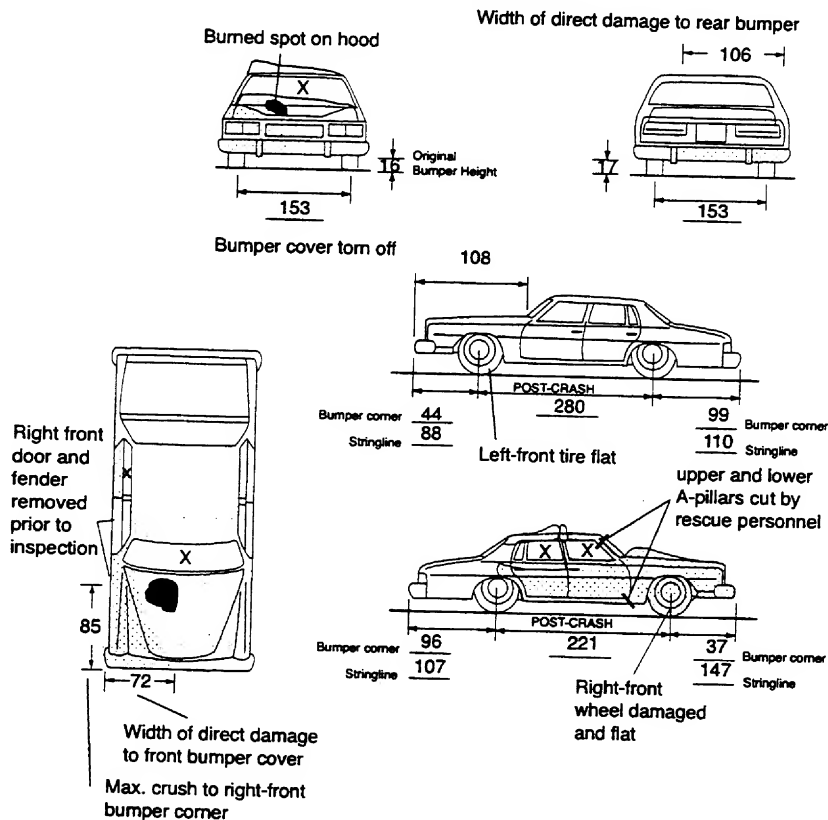
Direct Damage Length (DDL) 072 cm

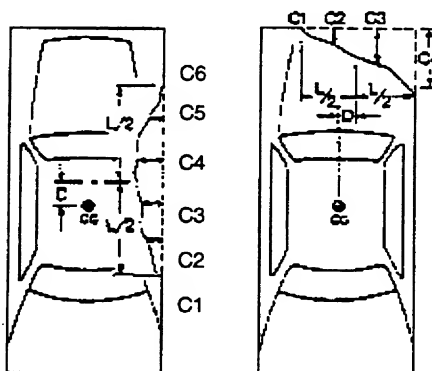
Specific Impact No.	Location of Direct Damage	Location of Field L
1	Begin Rt BC, 72 cm to left	FT Bumpers, BC to BC

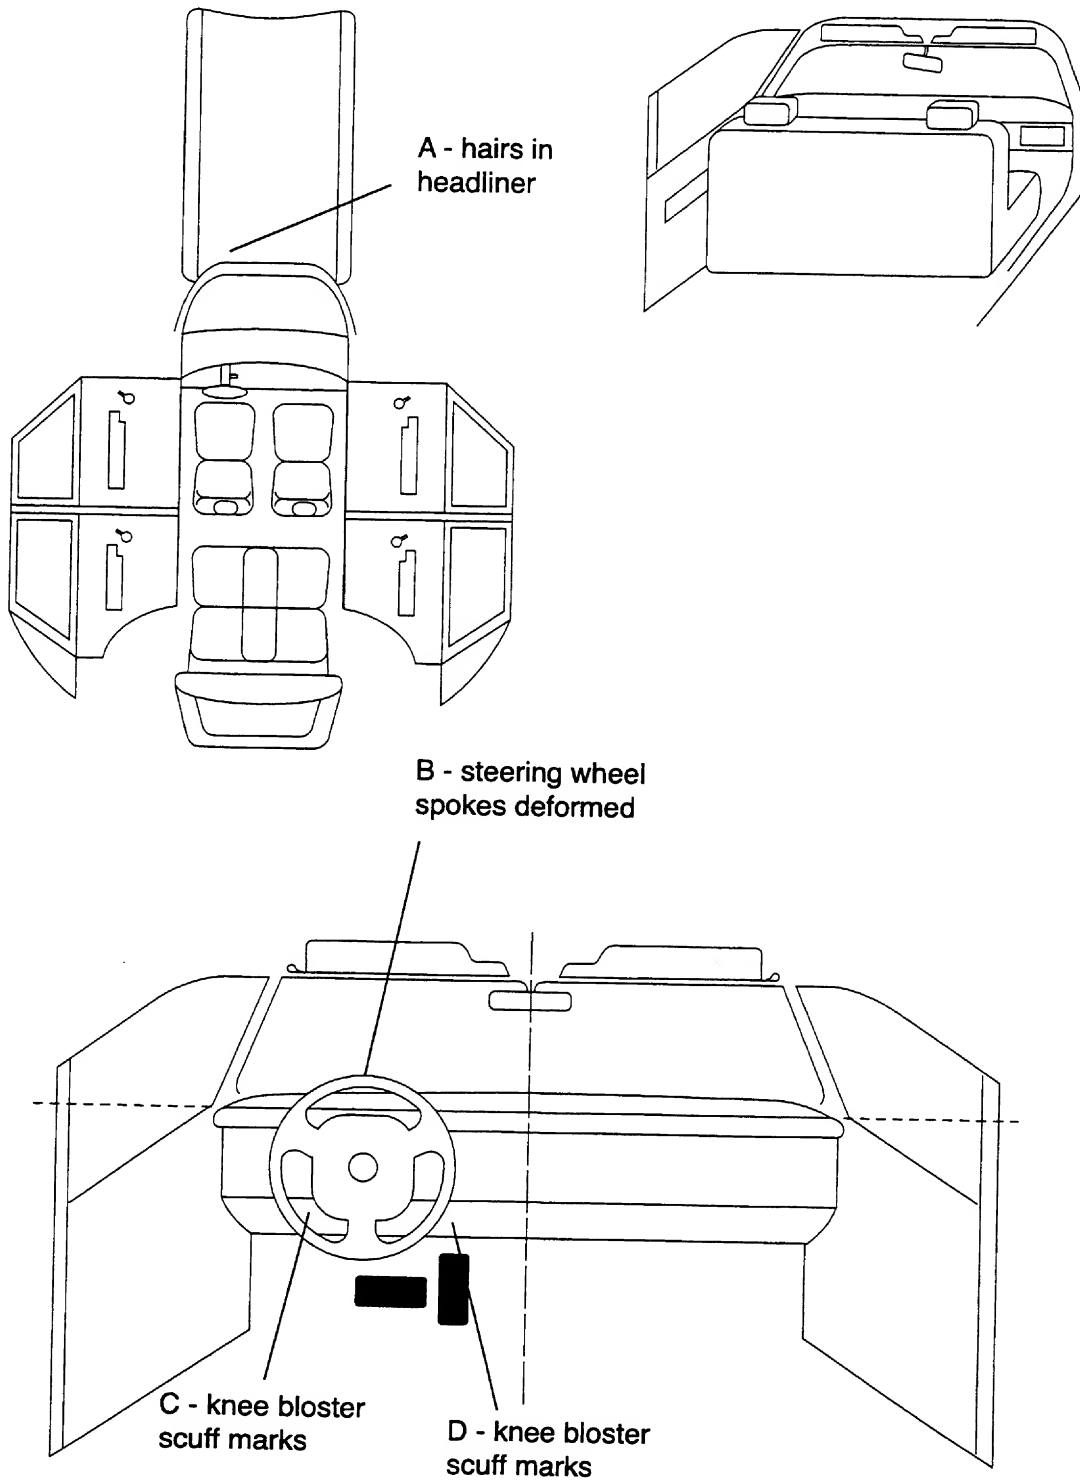
VEHICLE OCCUPANT CONTACT DIAGRAM

Contact	Interior Component Contacted	Occupant No. if Known	Body Region if Known	Supporting Physical Evidence	Confidence Level of Contact Point
A	Windshield Header	DR	Head	Hairs in headliner	2
B	Steering wheel	DR	Chest	Spokes deformed	1
C	Knee bolster	DR	Lt. leg	Scuff marks	1
D	Knee bolster	DR	Rt. Leg	Scuff marks	1
E					
F					
G					
H					
I					
J					
K
